Road Safety Audit

Lucan to City Centre

Core Bus Corridor Scheme
Stage 1 Road Safety Audit Report

Date September 2022

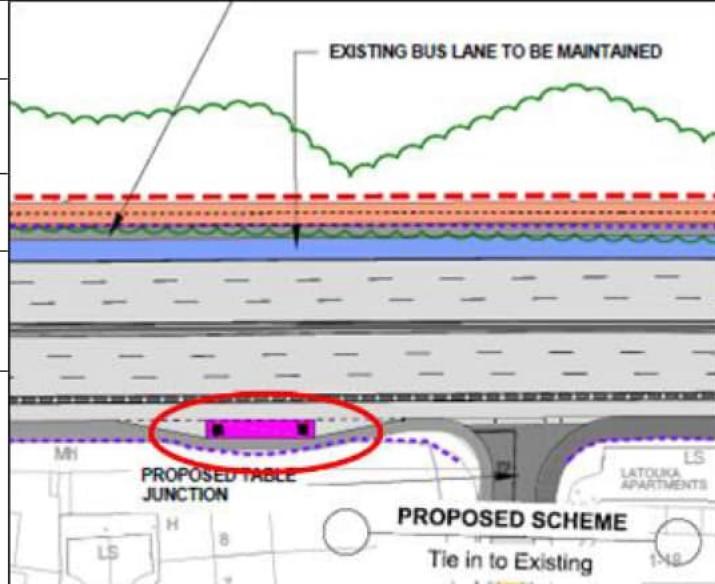
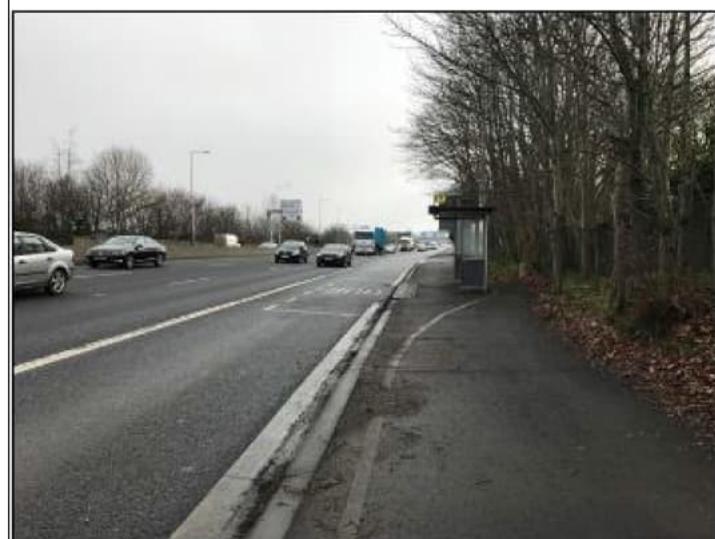
4.3.7 Problem

Location: Westbound Bus Stop to the west of Ballyowen Lane	
Drawing: Sheet 03 of 32	
Summary: Bus stop is too short	
Description: The westbound bus stop located to the west of Ballyowen Lane is too short in length. The bus stop does not have sufficient capacity to accommodate more than a single bus. This results in buses having to stop on the carriageway when there is already a bus occupying the bus stop. This will increase the risk of rear end shunt collisions with buses required to stop on the carriageway while waiting for another bus to depart the bus stop.	
Recommendation:	Provide a bus stop longer in length so it can accommodate more than a single bus.

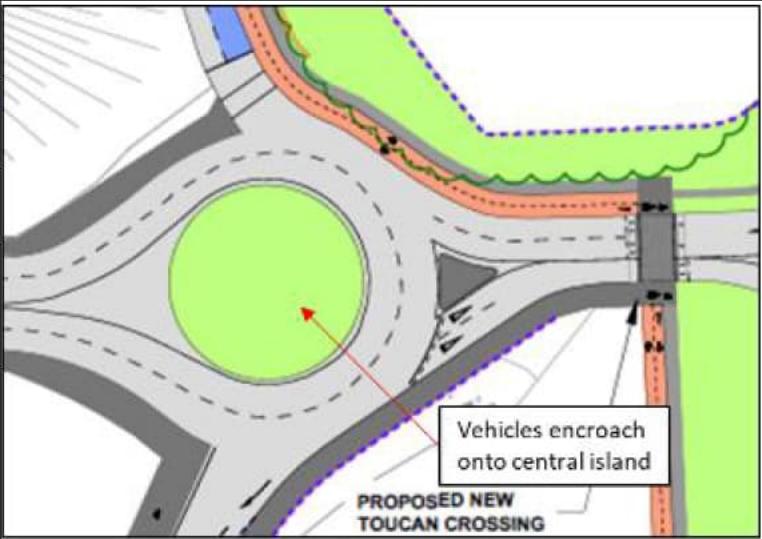
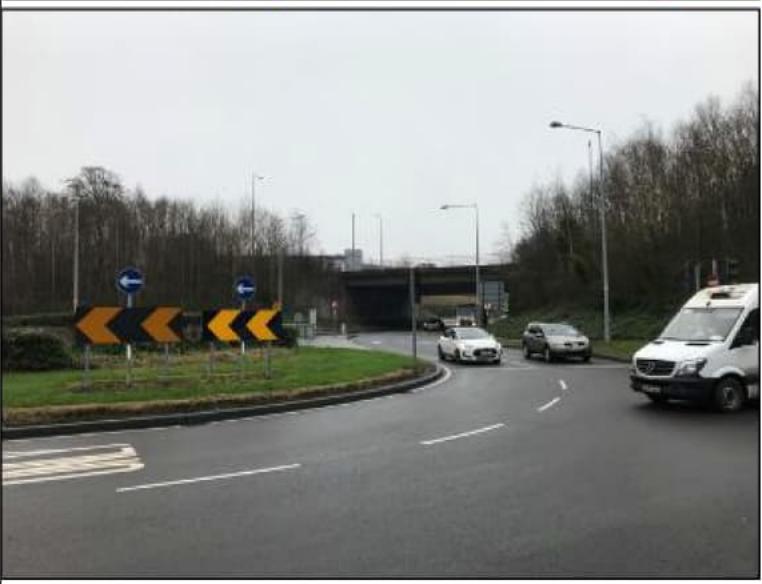
4.3.12 Problem

Location:	R113 roundabout to north of N4 at Junction 2
Drawing:	Sheet 06 of 32
Summary:	Vehicle encroach on island
Description:	Figure 3.2 R113 roundabout located north of N4 (Junction 2) It appears that larger vehicles occasionally encroach on the central island of the roundabout. This may result in loss of control and collisions.
Recommendation:	An overrun area should be provided so that large vehicles can negotiate the roundabout without having to mount the central island kerbing.

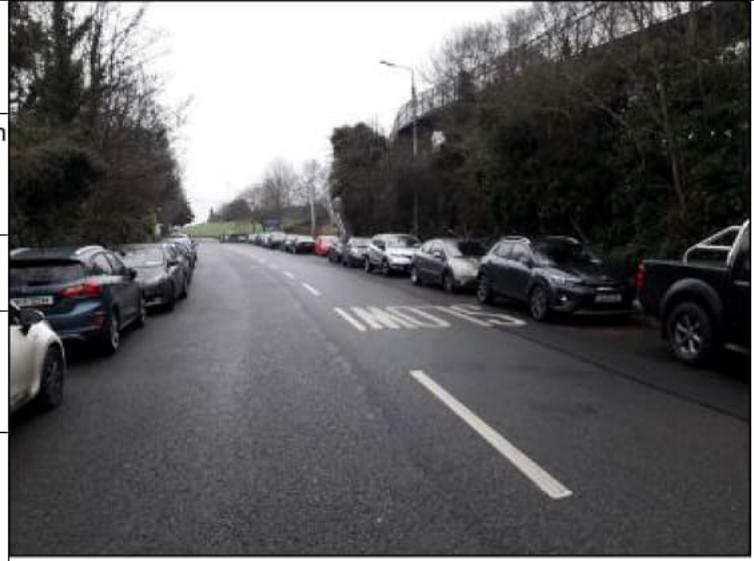
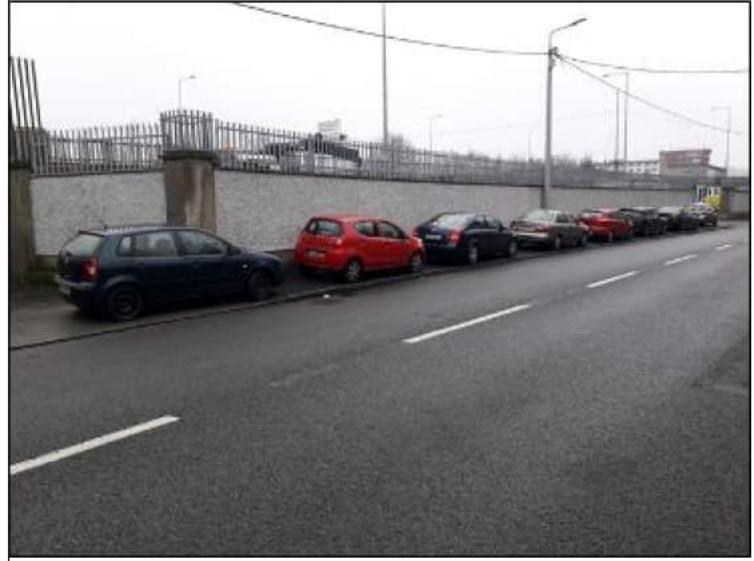
4.3.16 Problem

Location:	Old Lucan Road between R113 and The King's Hospital
Drawing:	Sheets 06, 07 & 08 of 32
Summary:	On-street parking along both sides of Old Lucan Road
Description:

Figure 3.3 On-street parking on Lucan Road between R113 and King's Hospital
On-street parking along Old Lucan Road was observed during the site visit. It is anticipated that motorists will want to continue to park at this location. Without parking restrictions or enforcement, motorists may park on the proposed two-way cycle track. Vehicles parked on the cycle track will likely result in cyclists having to use the carriageway thus increasing the risk of collisions with motorists.	
Recommendation:	
Parking enforcement measures should be provided on Old Lucan Road between the R113 and The King's Hospital.

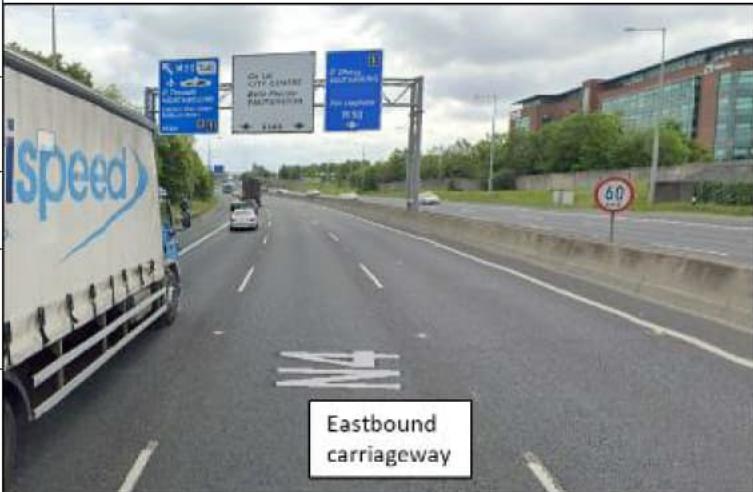
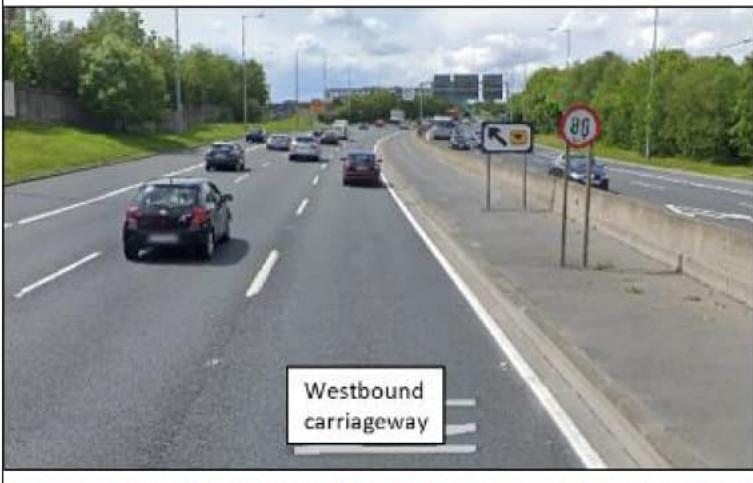
4.3.19 Problem	
Location:	N4 to the west of Junction 1 – both carriageways
Drawing:	Sheets 08 & 09 of 32
Summary:	High speeds observed at this location

Description:	Figure 3.5 Speed limit on eastbound approach to M50 interchange During the site visit it was observed that vehicles appeared to be travelling in excess of the posted speed limit. The provision of an additional bus lane, particularly on the eastbound approach, increases the complexity of the road layout. The existing speed limit on the approach may be unsuitable for the proposed layout and result in an increase in collisions.
Recommendation:	An assessment of the existing speed limits should be undertaken by the designers. If the speed limit is deemed unsuitable, discussions with TII should be undertaken with regard to reducing the speed limit at this location.

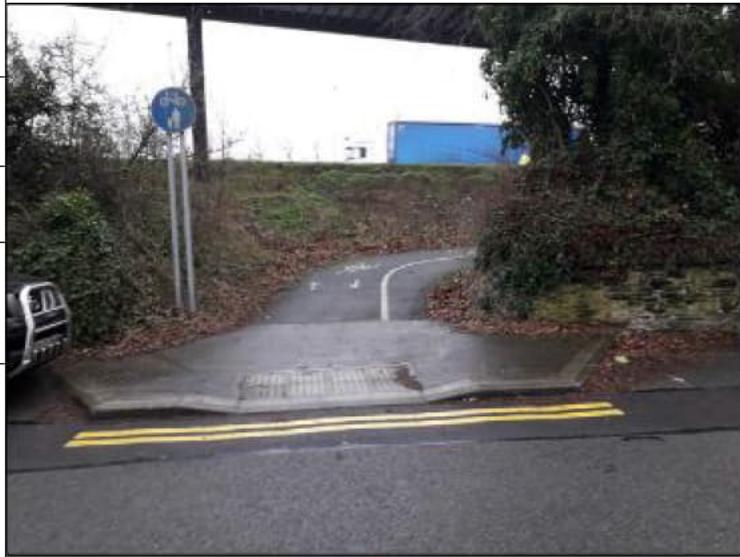
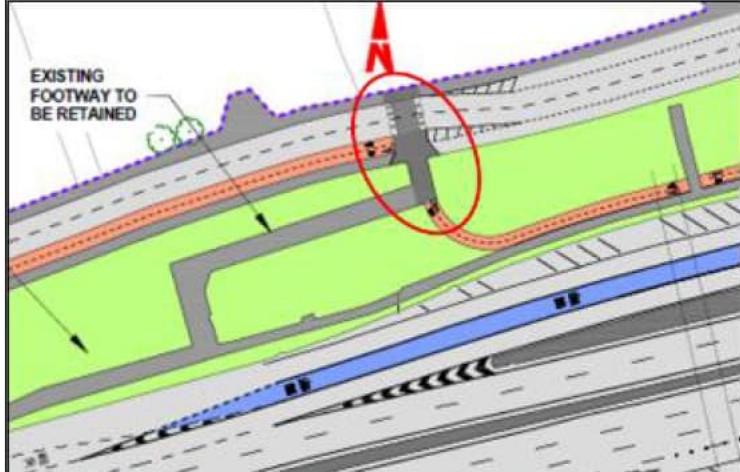
4.3.20 Problem	
Location:	Cycle track to the north of the N4
Drawing:	Sheet 08 of 32
Summary:	Proposed cycle track cut through embankment

Description: The proposed two-way cycle track along Old Lucan Road will cut through a steep embankment and link up with the two-way cycle track adjacent to the N4. Should the cycle track be constructed with a steep gradient at this location, this may result in collisions with cyclists losing control or unable to stop as they approach Old Lucan Road.	
Recommendation: The cycle way should be constructed so that the long fall gradient does not exceed 5% in accordance with the National Cycle Manual.

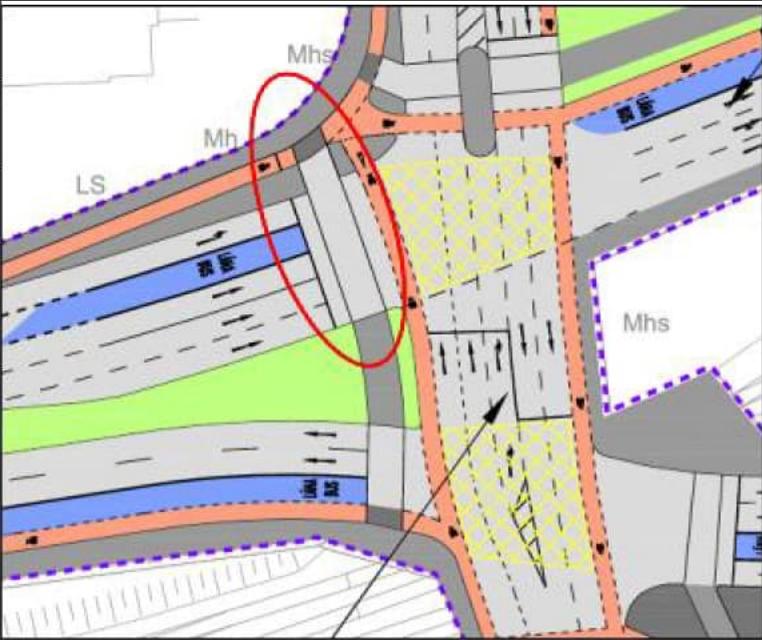
4.3.30 Problem	
Location:	South Circular Road junction
Drawing:	Sheet 28 of 32
Summary:	The length of the pedestrian crossing is excessive

Description:	Figure 3.7 Length of crossing is too long
The length of the crossing across the westbound carriageway of Con Colbert Road is excessive. The crossing traverses a cycle track and five lanes of traffic approximately 20m in length. If appropriate green times are not provided to pedestrians, this could result in vehicle/pedestrian collisions.	
Recommendation:	Appropriate green times should be provided to ensure pedestrians can cross in time.

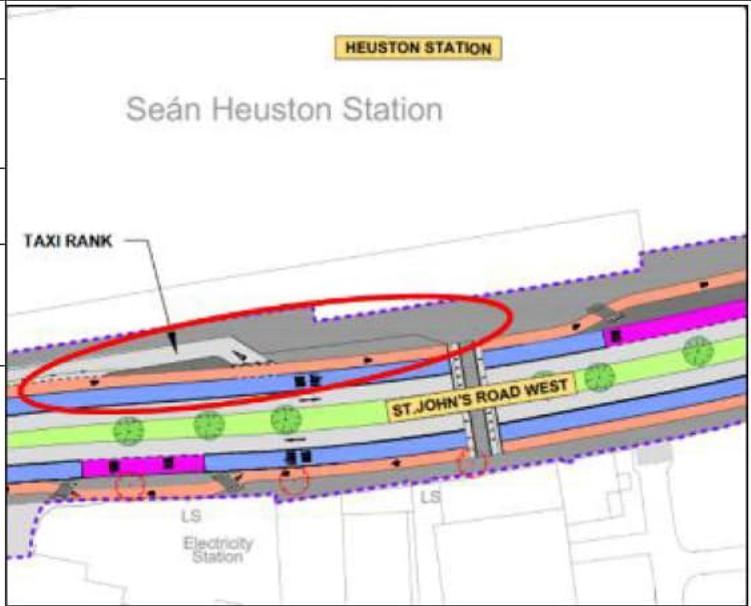
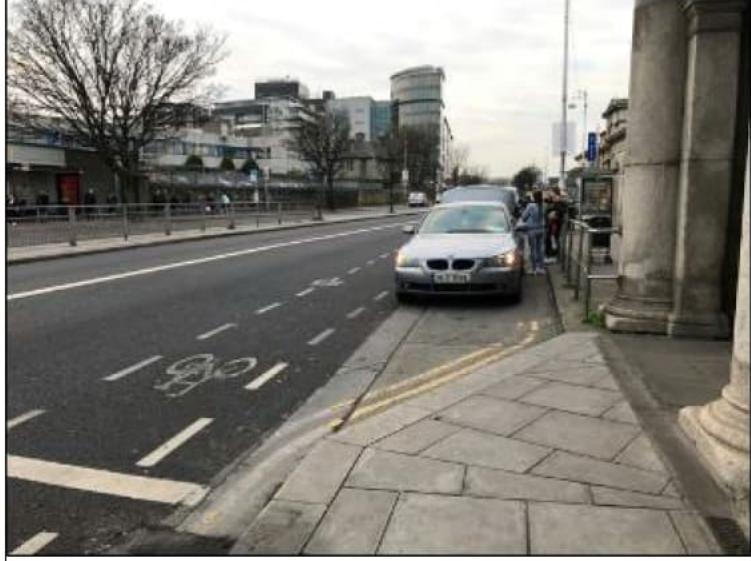
4.3.35 Problem	
Location:	Heuston Station pick-up/drop-off
Drawing:	Sheet 31 of 32
Summary:	Pick-up/drop-off has been removed

Description: It appears that the existing drop-off/pick-up area will be omitted to accommodate the proposed scheme. It is likely that private vehicles will use either the bus stop or taxi rank to drop-off/pick-up passengers. This is likely to result in delays and conflicts between private vehicles and buses and/or taxis, which could result in collisions.	
Recommendation: The existing drop-off/pick up area adjacent to the south elevation of Heuston Station should either be retained or an alternative drop-off/pick up area should be provided elsewhere for private motorists.

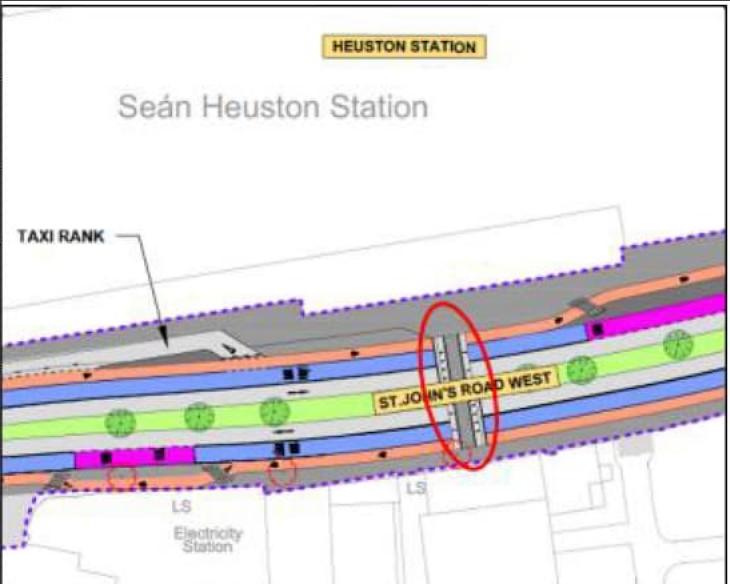
4.3.36 Problem

<p>The diagram shows a cross-section of the area around Seán Heuston Station. It features a 'TAXI RANK' at the top left. A road labeled 'ST.JOHN'S ROAD WEST' runs diagonally from the bottom left towards the top right. A red circle highlights a narrow speed bump or speed hump installed across the road. The area is surrounded by various buildings and infrastructure, including an 'Electricity Station'. Labels 'LS' are present near the base of the ramp.</p>
Location:	Heuston Station drop-off

Drawing:	Sheet 31 of 32
Summary:	Width of peed ramp is too short
Description:	<p>The speed ramp proposed on St. John's Road West adjacent to Heuston Station is too narrow for buses. This could result in ground of buses as they negotiate the ramp and possibly collisions. Increasing the length of the flat-top ramp is favoured by buses as they perceive it to reduce the discomfort for drivers and passengers together with maintenance and repair costs for their vehicles.</p>
Recommendation:	<p>A minimum flat-top length of 6m on bus routes, a height of 75mm together with ramp slopes of 1 in 15 should be installed as this represents a good balance between effective speed reduction and the potential drawbacks. This is in line in line with the requirements of the Traffic Management Guidelines.</p>

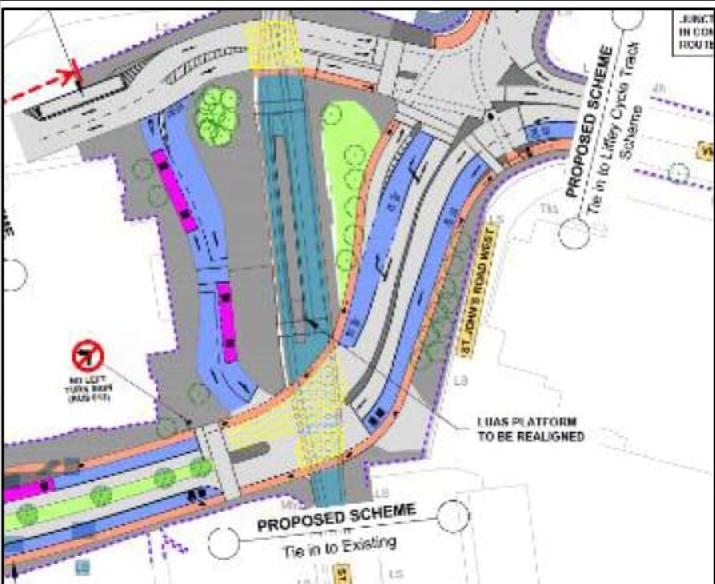
4.3.39 Problem	
Location:	St. John's Road West/Frank Sherwin Bridge/Victoria Quay junction
Drawing:	Sheet 31 of 32
Summary:	No Autotrack analysis done
Description:

Figure 3.12 Narrow pedestrian refuges	
No AutoTrack analysis has been undertaken at this stage of the project. AutoTrack analysis will demonstrate whether all types of vehicles can manoeuvre safely through the junction without encroaching onto pedestrian and shared spaces, cycle track or onto other lanes.	
Recommendation:	
Autotrack analysis should be undertaken to ensure that the junction can be negotiated by all vehicle types in a safe manner.

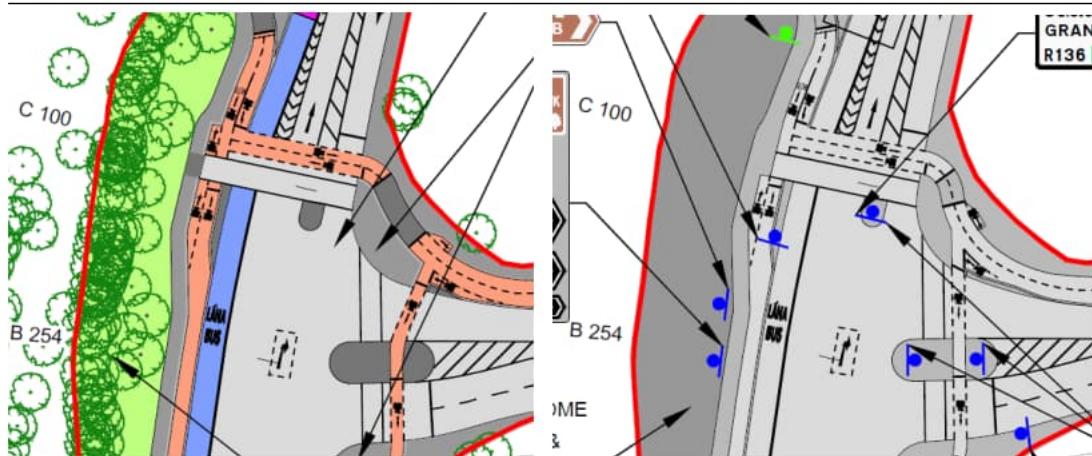
Summary: Differences in drawing series can lead to incorrect provisions.

It is noted that there are several inconsistencies of the cycle layouts between the separate drawing series. For example, as shown above at the R835 Lucan Road / R136 Ballyowen Road junction, when comparing the General Arrangement drawing to the Traffic Signs & Road Marking drawing, the alignment of the cycle crossings are different on the R136 Ballyowen Road for each drawing. The radii of the cycle tracks on the north-eastern side of the junction area are different. Also, the location of the western cycle right turn waiting area northbound on the Lucan Road is located at different positions either side of the Lucan Road pedestrian crossing. Inconsistencies in layout arrangement on construction drawings can lead to unsafe layouts and road markings which can result in pedestrian and cyclist collisions and injuries.

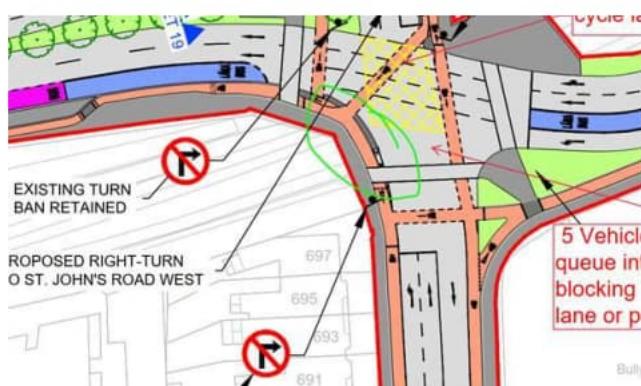
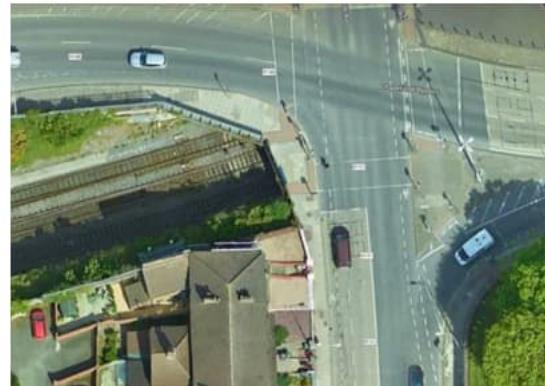
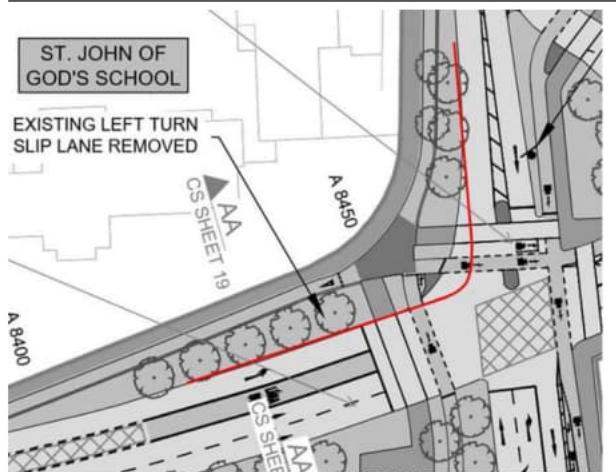
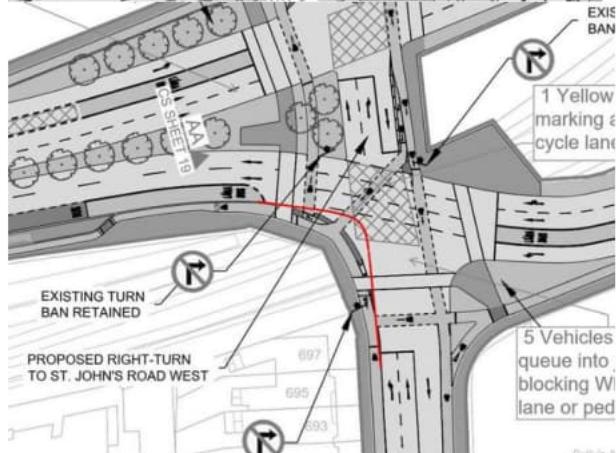
Summary: Large junction radii can lead to high turning speeds.

It is noted that there are several locations where the proposed junction radii are quite large, and in some locations larger than the current condition. Large turning radii can reduce the footpath space available and also encourage higher turner speeds which could lead to vehicles travelling too fast for the conditions and may result in vehicular collisions.

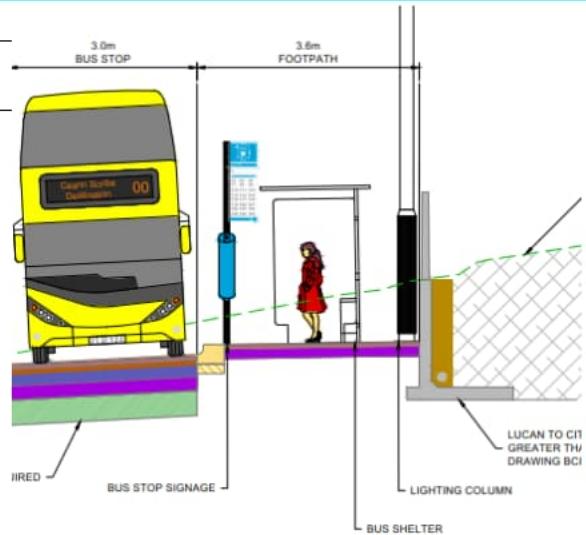
Summary: Lack of adequate width on footpath at bus stops can lead to pedestrian/vehicle conflicts.

Proposed bus shelters shown on drawing no. BCIDA-ACM-GEO_CS-0006_XX_00-DR-CR-0009, show that the bus shelters are offset from the rear of the footpath. Therefore, at the bus shelters, the clear width of available footpath to the rear and front of the bus shelter is reduced and restricted for footpath users. Without the appropriate width of pavement, there may be a lack of manoeuvrability and passing space between the bus shelter and edge of footpath. This can lead to pedestrians stepping into the carriageway to avoid other NMUs and coming into conflict with vehicles which could result in pedestrian collisions.

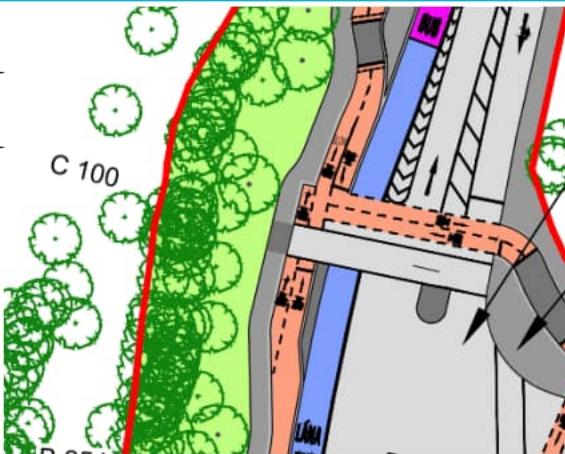
Summary: Lack of cycle push-button facilities can lead to cyclist/pedestrian collisions.

The cycleway traverses the signalised pedestrian crossing on the Lucan Road. Stop lines are provided within the cycleway in both directions in advance of the pedestrian crossing. When the pedestrian phase is called, the traffic signals will turn red. These signal aspects will be visible to all eastbound traffic. As no low level cycle signals are provided in advance of the pedestrian crossing, eastbound cyclists may not be aware that the pedestrian phase is activated, which can lead to cyclists colliding with pedestrians resulting in pedestrian and cyclist falls.

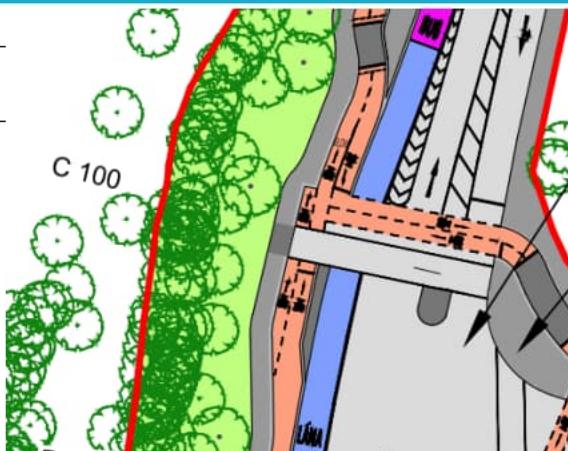
Summary: Lack of tactiles and signage can lead to cyclist/pedestrian collisions.

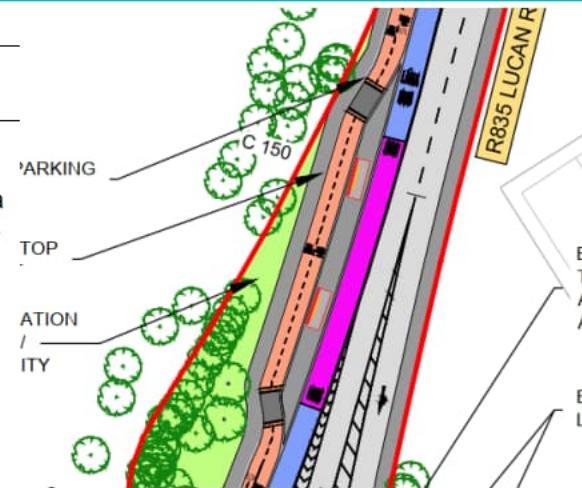
Summary: Risk of pedestrians sustaining personal injuries when attempting to transition between footway and bus boarding area due to lack of crossing across cycleway.

It is recommended that appropriate infrastructure such as a raised island is provided to enable all footpath users to transition safely between the footway and bus stop island.

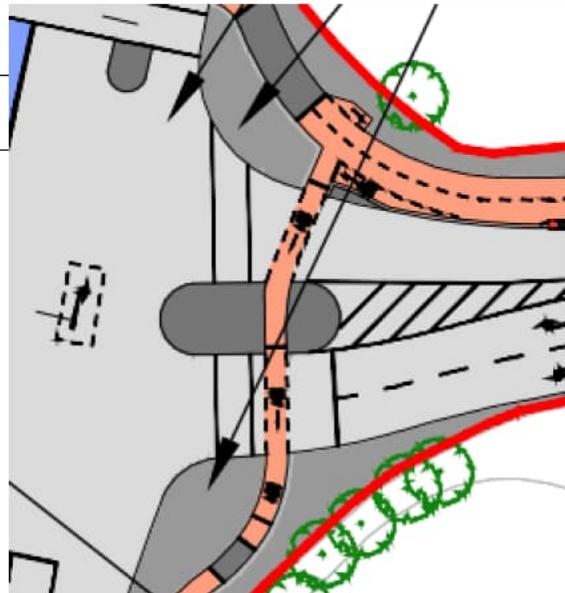
Summary: Insufficient cycle storage on splitter island could lead to pedestrian/vehicle or cycle/vehicle collisions.

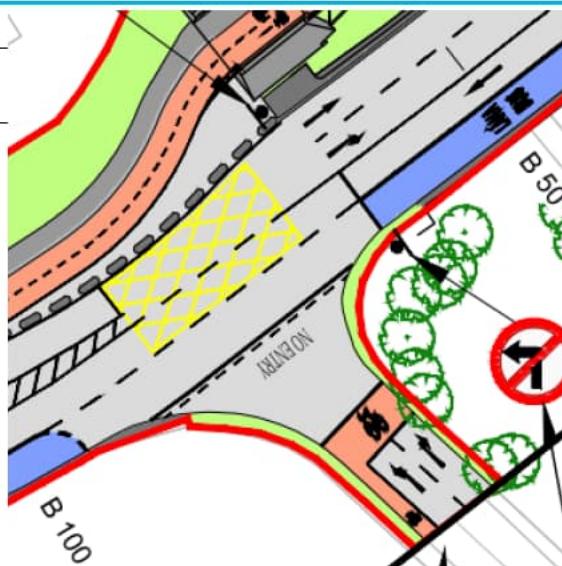
Summary: Restricted access to the cycle track can lead to cycle/vehicle collisions.

There is an existing cycle track on the nearside of the N4 Junction 3 off-slip road with a cycle storage area in advance of the vehicle stop line at the junction with the R136 Ballyowen Road. The existing uni-directional northbound cycle track on the western side of the R136 Ballyowen Road is proposed to be replaced by a bi-directional cycle track located on the eastern side of the R138, behind the existing safety barrier. There does not appear to be an opening proposed within this safety barrier.

Therefore, cyclists travelling from the N4 off-slip road onto the R138 will not be able to access the bi-directional cycle track on the R138 directly. This will result in cyclists having to travel on the R138 carriageway and may undertake unsafe manoeuvres to access the proposed cycle track, which may lead to cycle/vehicle collisions resulting in cyclist injuries.

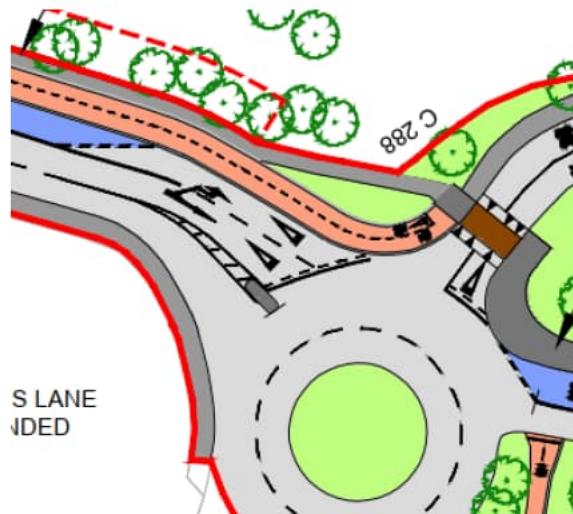
Summary: The road marking arrows are misleading and could lead to side swipe collisions.

The roundabout at the eastern end of Lucan Road has road markings for 2 no. circulatory lanes. The offside lane of the Lucan Road approach to the roundabout junction has a straight ahead arrow and the nearside lane has a left turn only arrow. If the left turn arrow is obscured, vehicles may enter this lane and proceed to access the N4 On-slip from this lane. This may cause side swipe collisions with vehicles in the outer offside lane also going straight ahead onto the N4 on-slip lane leading to vehicular collisions.

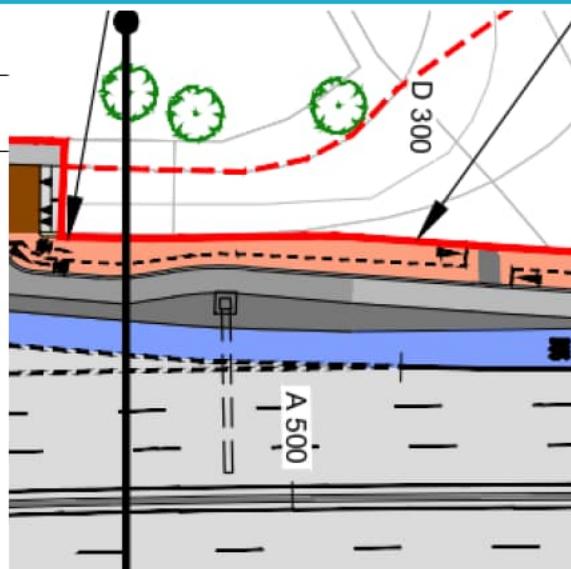
Summary: Narrow bus lane could result in vehicle side swipe collisions.

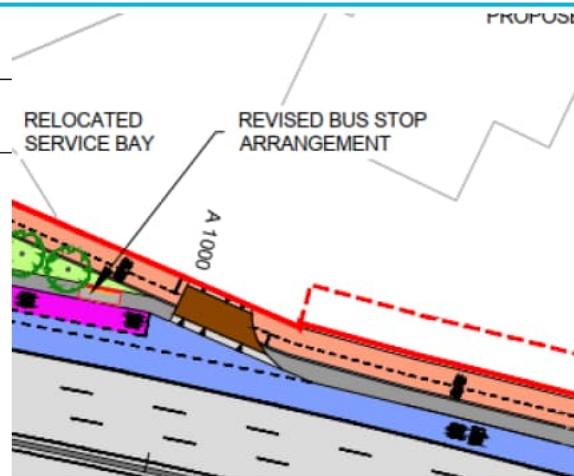
Summary: Risk of visually impaired or wheelchair users crossing on a slope could lead to falls.

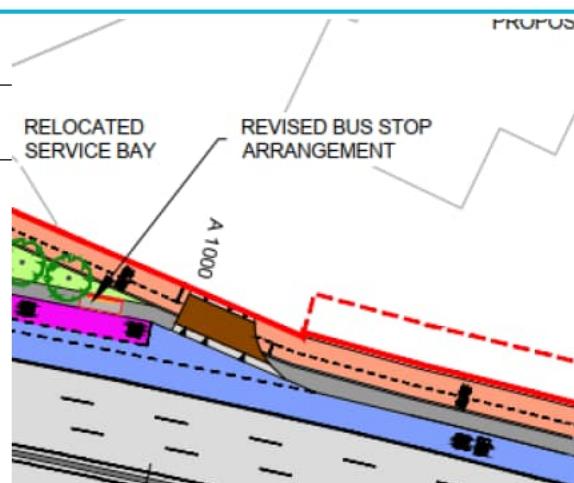
Summary: Risk of visually impaired pedestrians misinterpreting crossing.

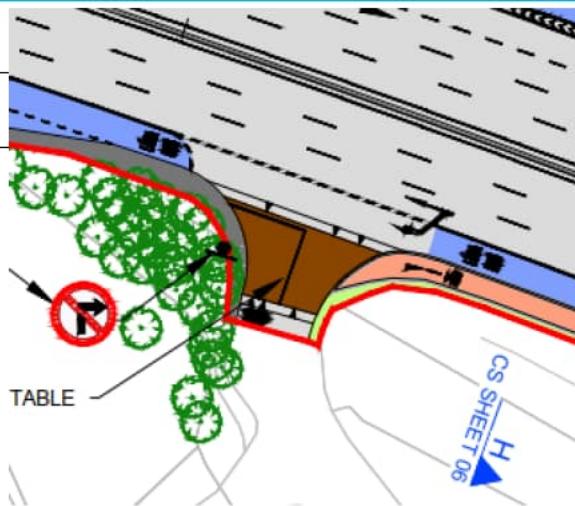
Summary: Cycle route terminates without onward direction.

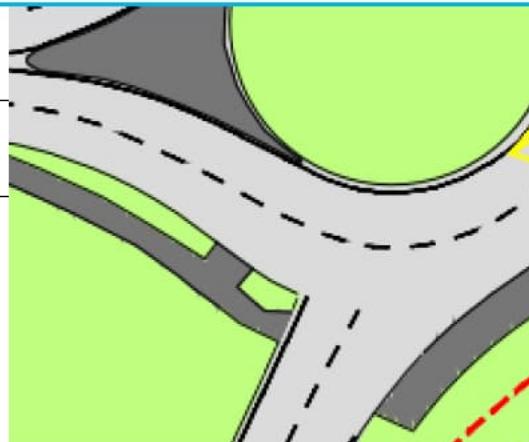
Summary: Proposed footpath link directs NMUs into the carriageway.

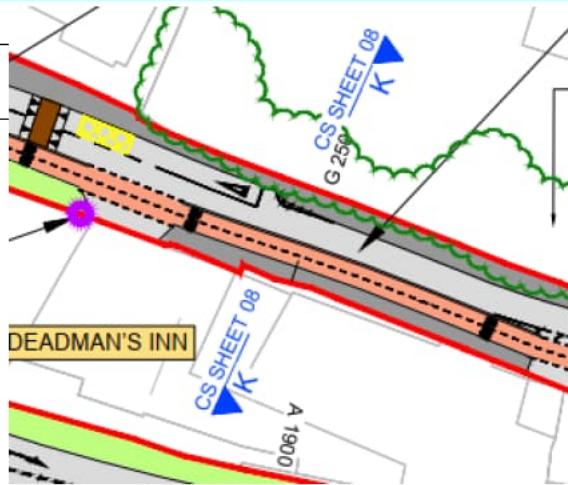
Summary: No pedestrian crossing facility is provided across the Old Lucan Road.

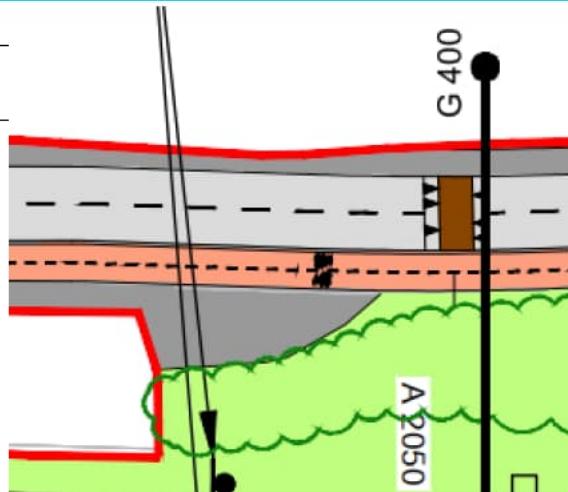
Summary: Cars may park on the cycle track on the Old Lucan Road.

There is currently uncontrolled on-street car parking along the southern side of the Old Lucan Road. As there is a bus stop a short distance away, this section of the Old Lucan Road may be used as a parking area for city bound bus users. If alternative sufficient parking facilities are not provided to replace the current on-street parking, this can lead to cars parking in the cycle track. This will result in cyclists having to veer into and out of the Old Lucan Road carriageway, which could result in a cyclist/vehicular collision.

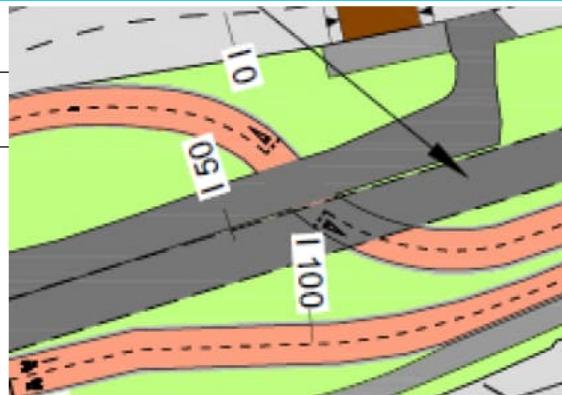
Summary: A steep gradient on the proposed cycle track may cause cyclists to lose control

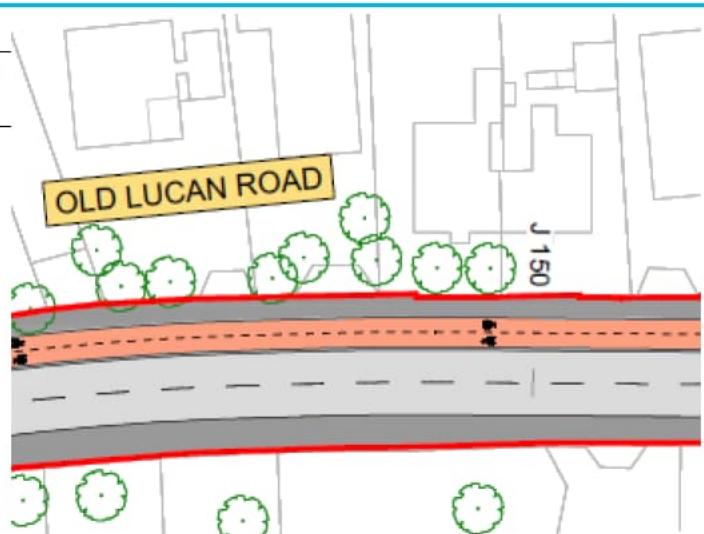
Summary: Vehicles may park on the cycle track on the Old Lucan Road.

There is uncontrolled on-street parking along the northern side of the Old Lucan Road. If alternative sufficient parking facilities are not provided to replace the current on-street parking, this can lead to cars parking in the cycle track. This will result in cyclists having to veer into and out of the Old Lucan Road carriageway, which could result in a cyclist/vehicular collision.

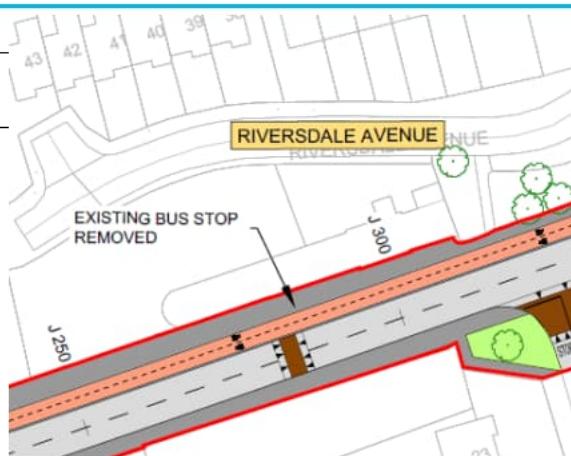
Summary: Relocation of Bus stops may restrict non-motorised user journeys causing conflict with vehicles.

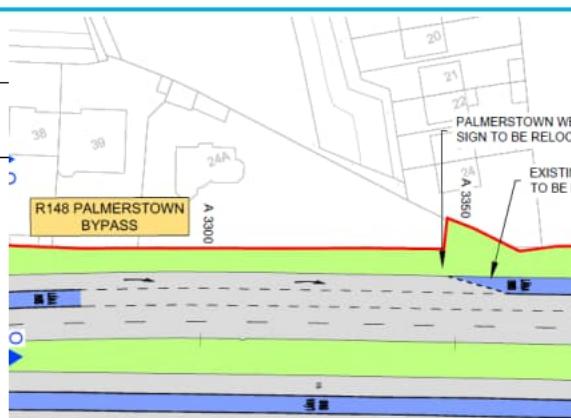
Summary: Short merge length for opposing crossover manoeuvres may lead to side swipe collisions.

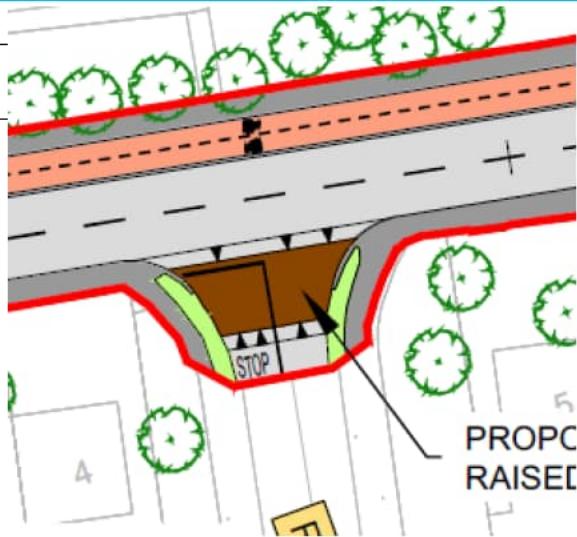
Summary: Risk of visually impaired pedestrians misinterpreting level difference or wheelchair users crossing on a steep crossfall.

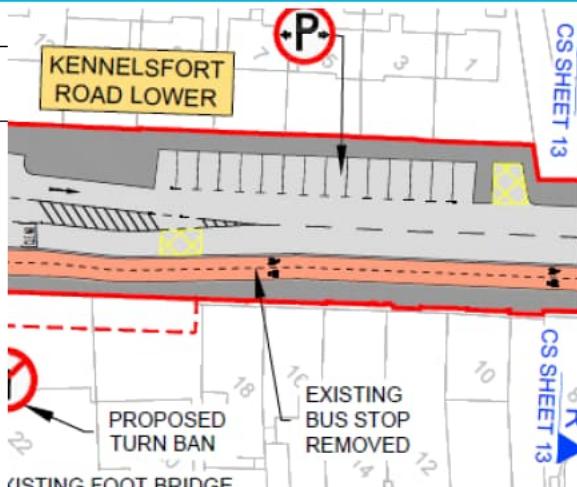
Summary: Relocation of Bus stops may restrict non-motorised user journeys causing conflict with vehicles.

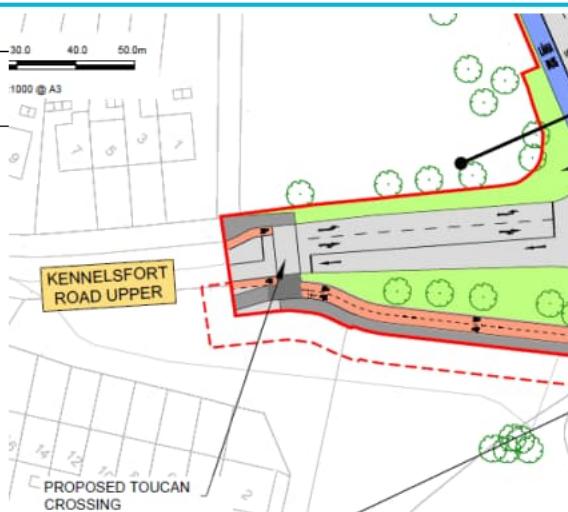
Summary: Risk of left turning vehicles striking and injuring cyclists.

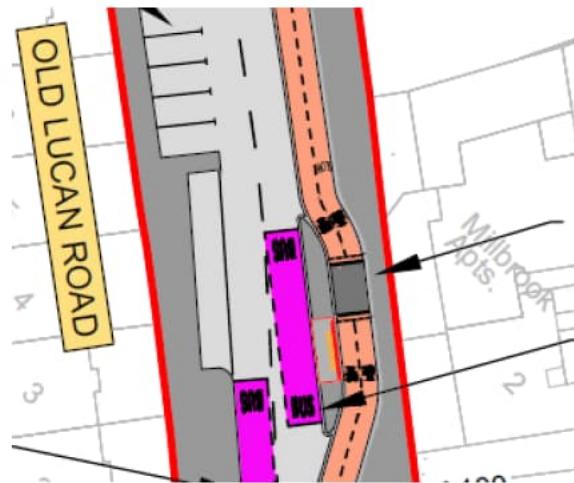
Summary: Risk of pedestrians sustaining personal injuries when attempting to transition between footway and bus boarding area due to lack of crossing across cycleway.

It is recommended that appropriate infrastructure is provided to enable all footpath users to transition between the footway and bus stop island.

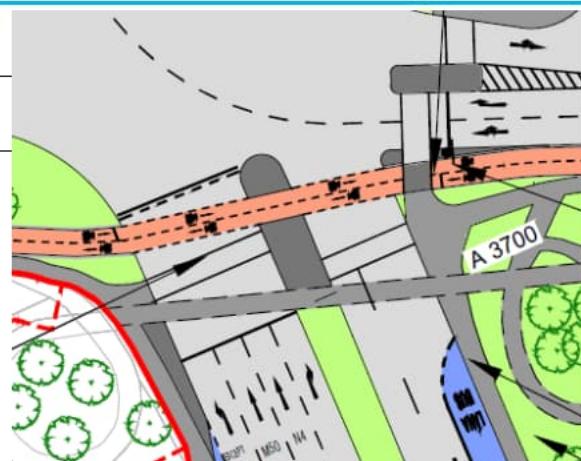
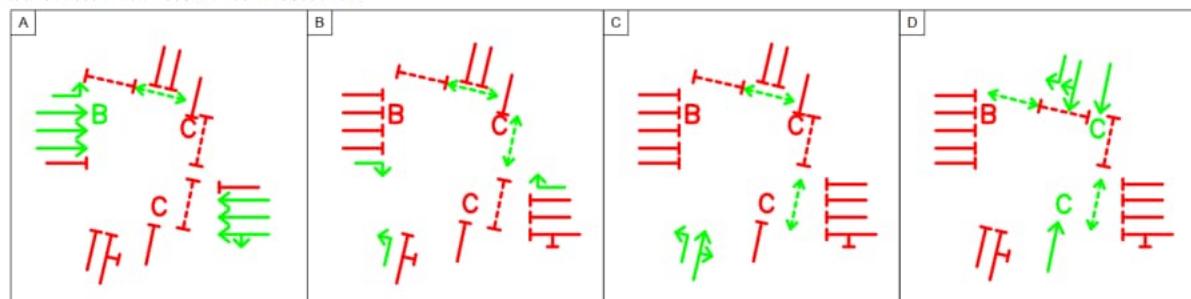
Summary: Risk of pedestrians crossing the R148 carriageway when it is not safe to do so and being struck and injured by vehicles.

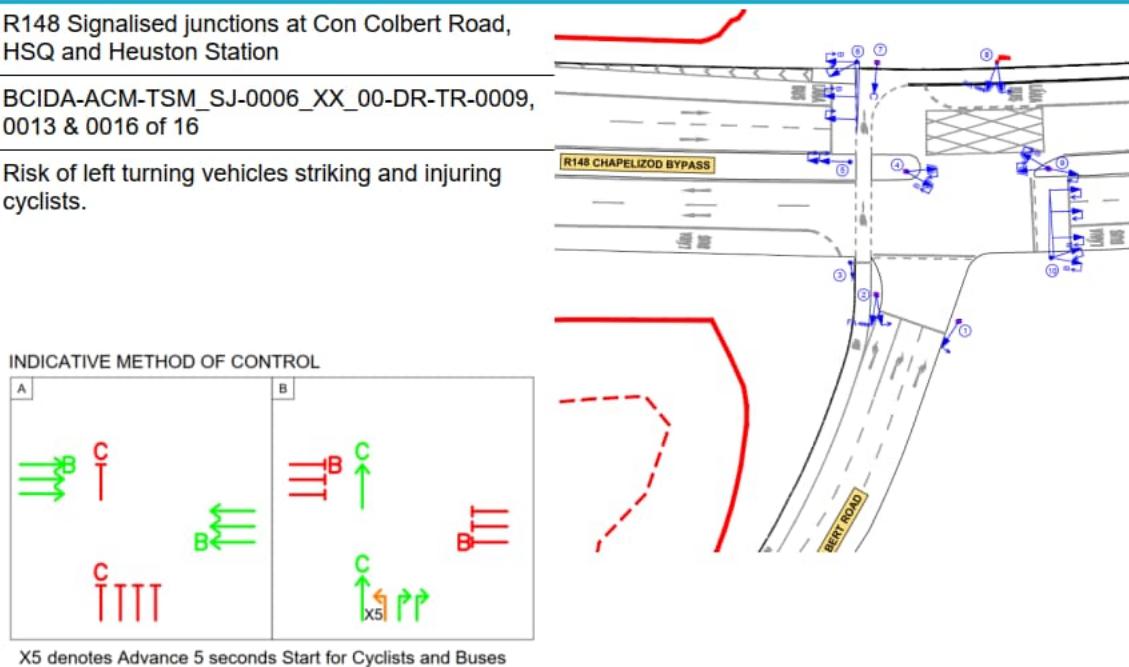
Summary: Risk of left turning vehicles striking and injuring cyclists.

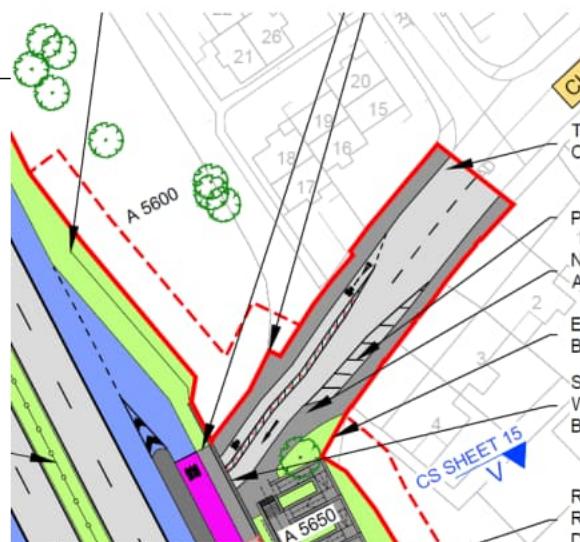
Summary: Risk of opposing cyclists collisions in uni-directional cycle track.

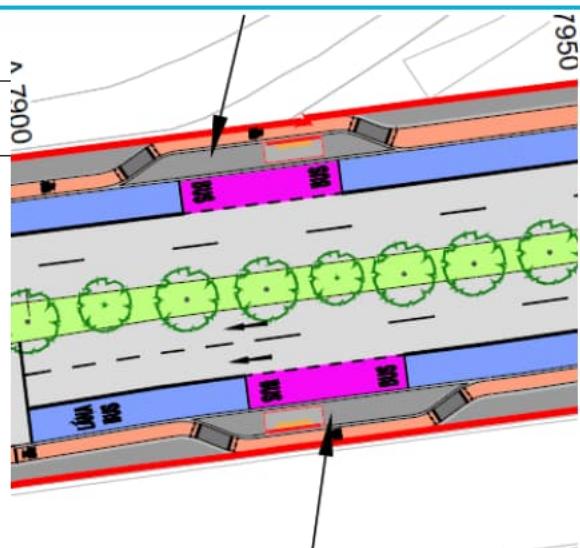
Summary: Risk of cyclists losing control due to geometry of cycleway, leading to falls.

There are several points along the route where the geometry of the radii of the uni-directional cycle route appears tight. This could cause issues for users on longer bicycles, such as recumbent, cargo or tandem bicycles. The locations include:

At these points tight radii appear to be proposed when the cycle track diverts to bypass the proposed bus stops. This could lead to cyclists losing control, particularly in wet conditions, which could lead to cyclist falls, resulting in cyclist injuries.

It is recommended that swept path analysis is undertaken on the proposed layouts using different types of bicycle and that the design is appropriately amended, if required.

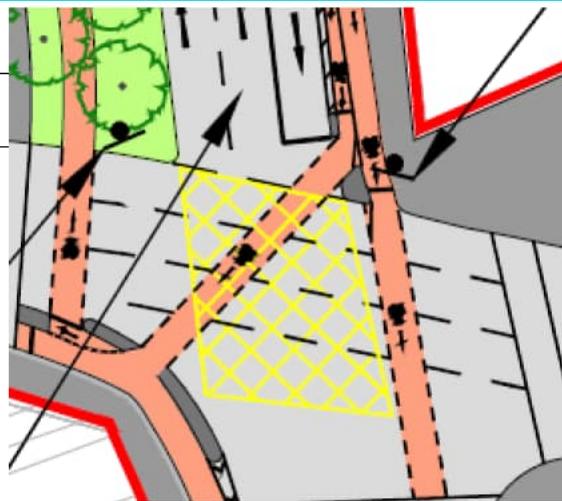
Summary: Yellow box road markings may lead to cyclist slips.

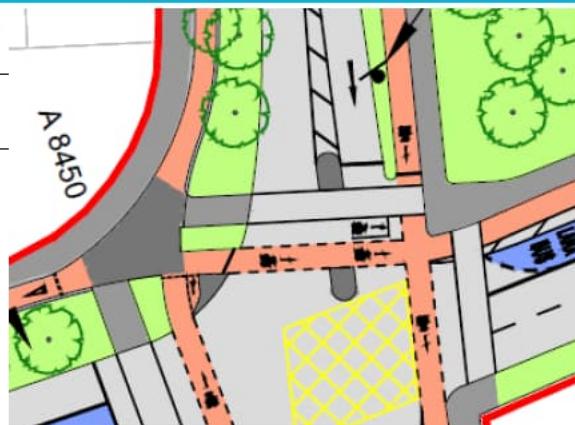
Summary: Right Turn Pocket for Cyclists (RTPC) may lead to collisions with vehicles.

It is also unclear as to the proposed number of cyclists expected to turn right at this junction. The extent of space available for right turning cyclists to wait is quite restricted. If there is insufficient storage area for cyclists turning right in the southbound direction to wait, it can lead to cyclists backing up into the northbound lane. Failure to provide adequate cyclist storage in this area may lead to collisions between southbound cyclists and vehicles travelling on the R111 straight through this junction.

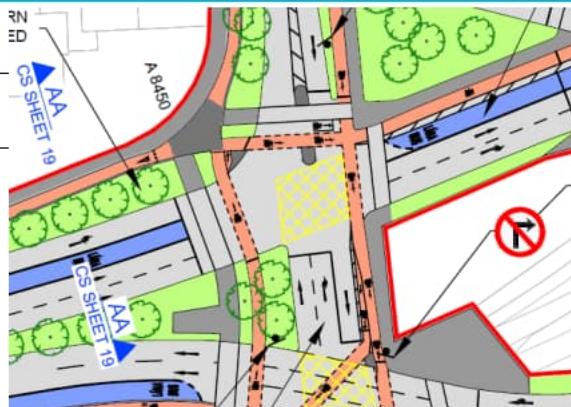
Summary: Risk of side swipe and rear end shunt collisions between signalised junctions.

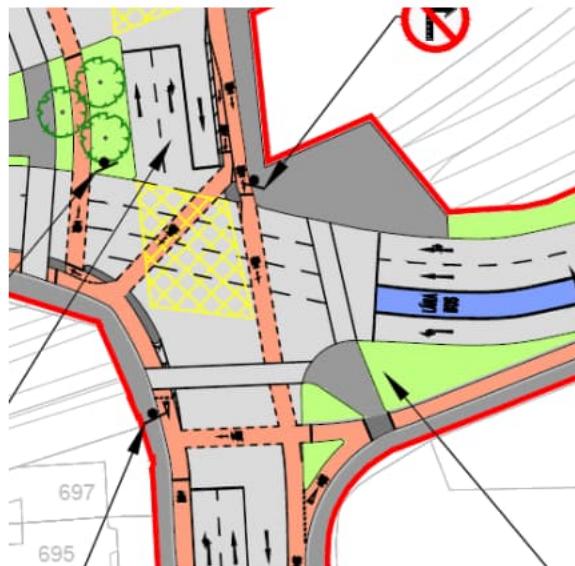
Summary: Vehicles blocking the junction may result in vehicle and/or pedestrian collisions.

A new right turn lane is proposed for South Circular Road northbound vehicles to access the R148 eastbound. The storage length of this right turn facility is quite short in length and will not accommodate many vehicles. A high number of right turning vehicles may block this junction leading to following vehicles undertaking erratic unsafe manoeuvres or vehicles left waiting on/in the yellow box, on the pedestrian crossing or on the cycle lane across South Circular Road (south). This could lead to vehicle collisions with traffic westbound on the R148, or pedestrian/cycle collisions with vehicles on the South Circular Road.

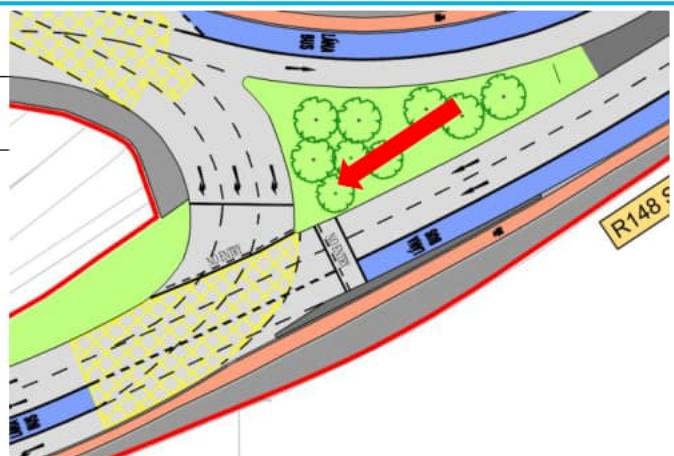
Summary: Vegetation blocking traffic signals can lead to vehicle collisions

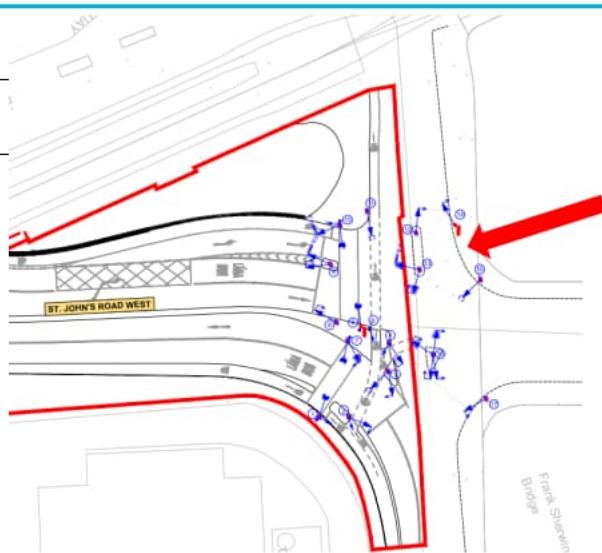
Summary: Lack of a pedestrian phase can lead to pedestrian collisions with vehicles.

The proposed traffic signals staging diagram is shown on drawing no. BCIDA-ACM-TSM_SJ-0006_XX_00-DR-TR-0016. No pedestrian crossing phase is shown on the proposed signal staging diagrams. It is unclear what pedestrian crossing facilities will be provided for footpath users crossing the Heuston Station access road to/from the Frank Sherwin Bridge to/from Heuston Station. There is a risk that pedestrians may cross the Heuston Station access road at a location where it is unsafe to do so which may result in pedestrian collisions with vehicles or cyclists.
