Road Safety Audit

Lucan to City Centre

Core Bus Corridor Scheme
Stage 1 Road Safety Audit Report

Date September 2022

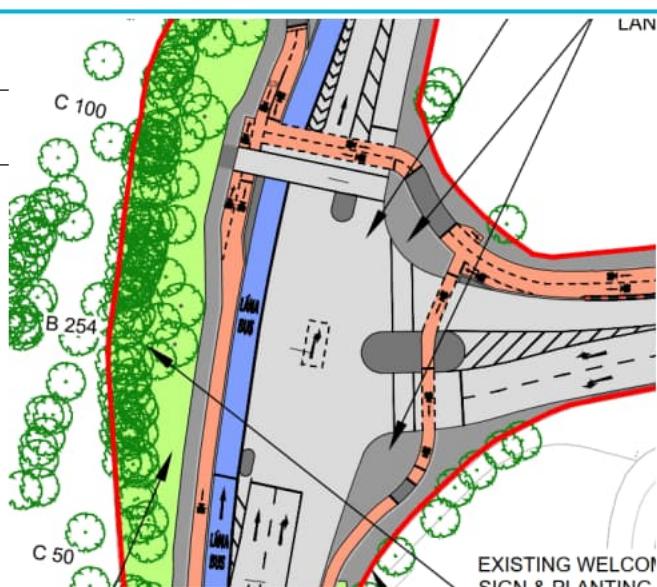
Summary: Insufficient protection to the bus lane could lead to bus/vehicle side swipe collisions.
