Appendix D Arboricultural Impact Assessment Report

BusConnects Core Bus Corridor Lucan to City Centre

Arboricultural Impact Assessment Report BCIDA-ACM-ENV_LA-0006_XX_00-RP-ES-0001

National Transport Authority

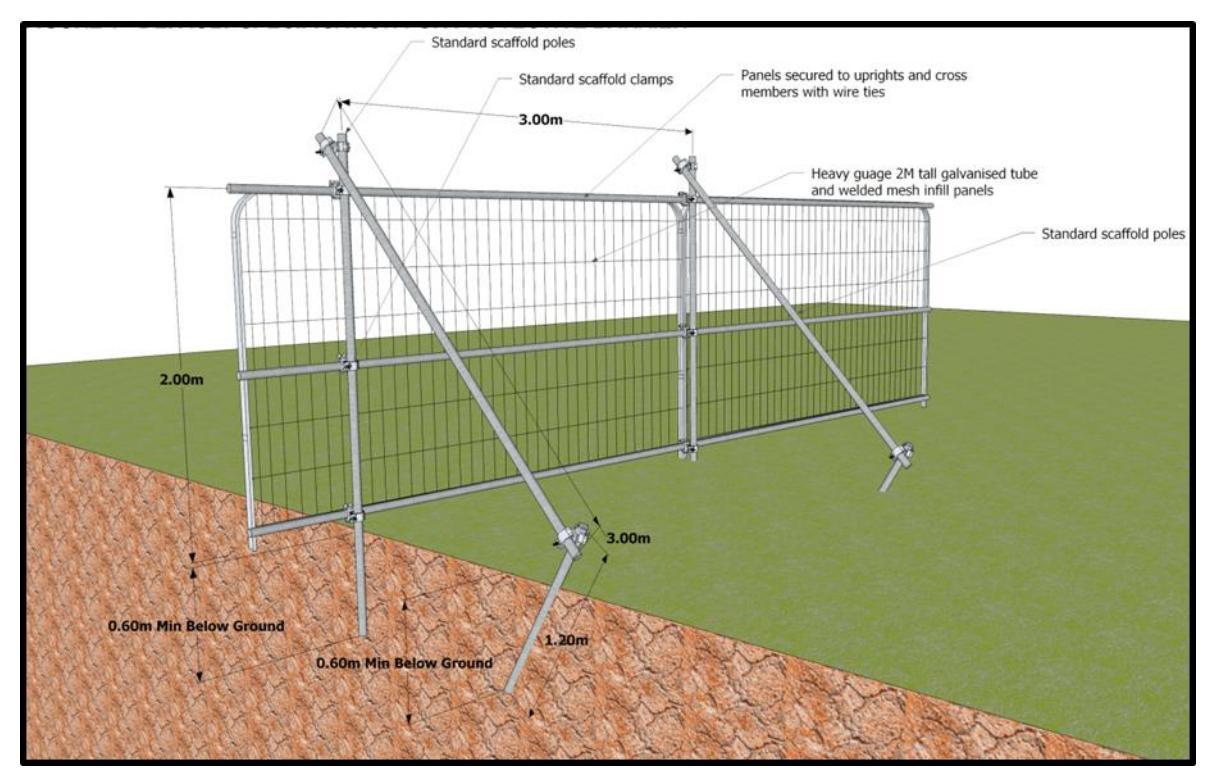
Figure 3 Default specification for tree protection barrier in accordance with BS5837:2012 figure 2.

Fencing shall be constructed with robust vertical and horizontal scaffold framework with weldmesh panels firmly attached in accordance with BS 5837:2012 Figure 2. Vertical support poles and bracing poles must be located with care to avoid underground utility services and will be sited to avoid the structural roots of retained trees. Where driven supports are not feasible due to the presence of roots or underground utilities block trays, counterweights or equivalent can be utilised.
